Roof over PGE Arena in Gdansk. Review of structure and monitoring system.

Summary:

This paper presents general structural assumptions of the steel construction designed for a new football stadium to be built for UEFA Championship 2012 in the city of Gdańsk. The superstructure is founded directly on the modified abutment. The facade and the roof are collected from 82 steel girders made of tube profiles. The girders are braced by circular beams and X tension rods. All this creates a quasi – dome covered by polycarbonate cladding. During the fabrication and erection several problem occurred. Major difficulties and repairing procedures are presented here.

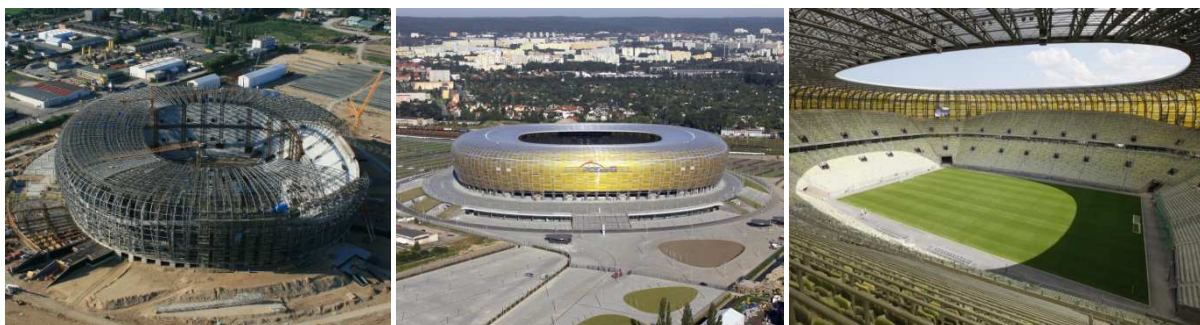
The most spectacular part of the stadium is a steel roof and facade structure. Its characteristic shape and transparent cladding in tones of yellow shows the architect's vision mentioned before – a lump of amber.

Fig.1 PGE Arena. Photo taken 22.8.2010 (www.bieg2012.pl) and after the opening

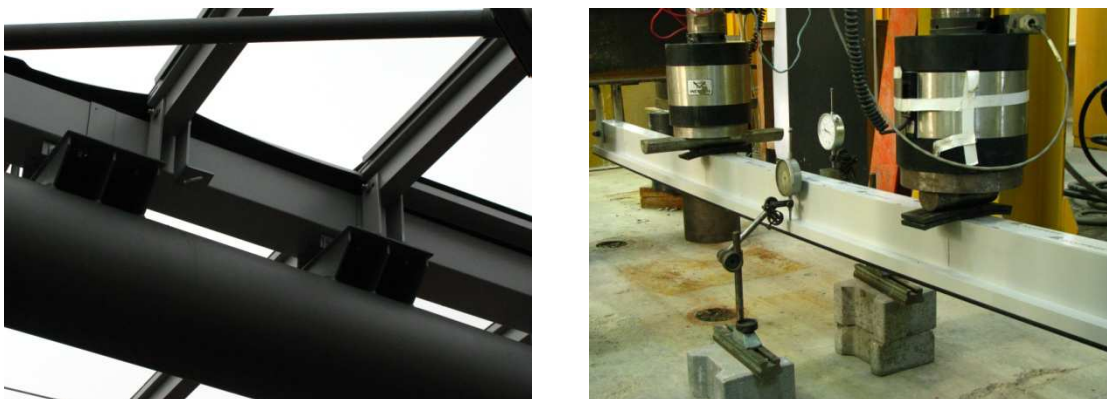
Fig.5 Aluminium sub construction and laboratory test of aluminium roof profile.

The cladding of the roof, designed as a membrane made of polycarbonate, is supported by a special aluminium sub construction. (fig. 5) The roof is equipped with inspection platforms, rainwater drainage system, snow fences, lighting installation, four media screens, sound system and other equipment.

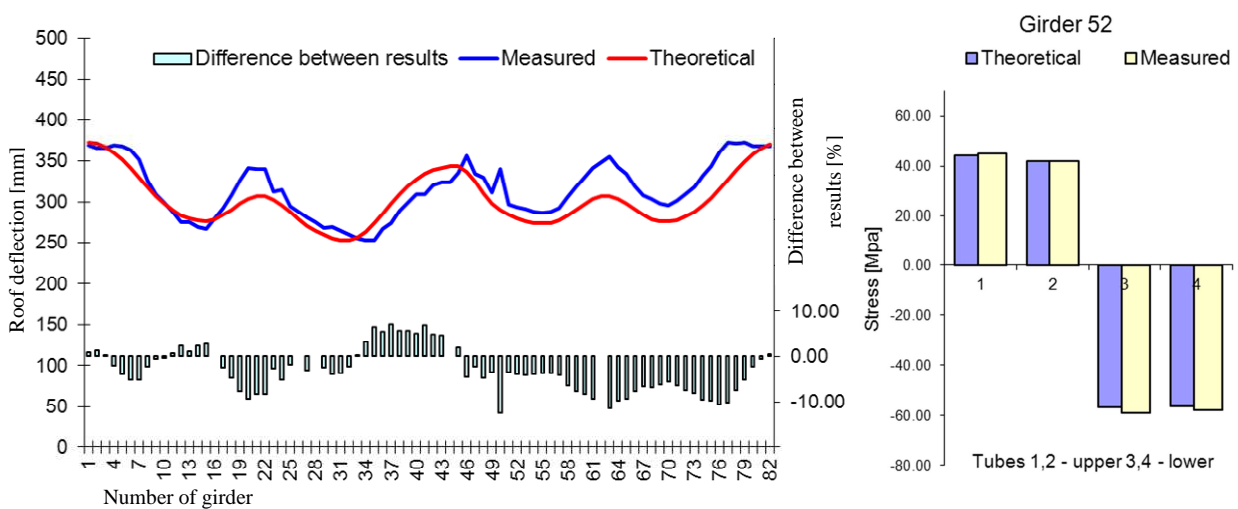
Fig.9 Comparison of numerical and measured results

An extreme deflection was measured on the girder 79 with value of 440 mm. The value obtained from numerical analysis was 417 mm. The biggest difference of 12.4% was on the girder 50. An average difference was calculated as 4.92%.

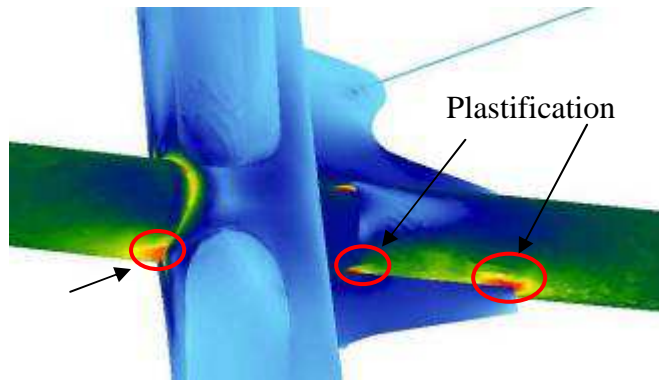
Fig.12 Visualisation of the node with marked places where steel exceeds yield strength

The numerical analysis revealed strength reserves of steel in the deformed node, which allowed to accept the procedure of repairing. After revealing the imperfection in the few first girders, it was eliminated in the next ones.

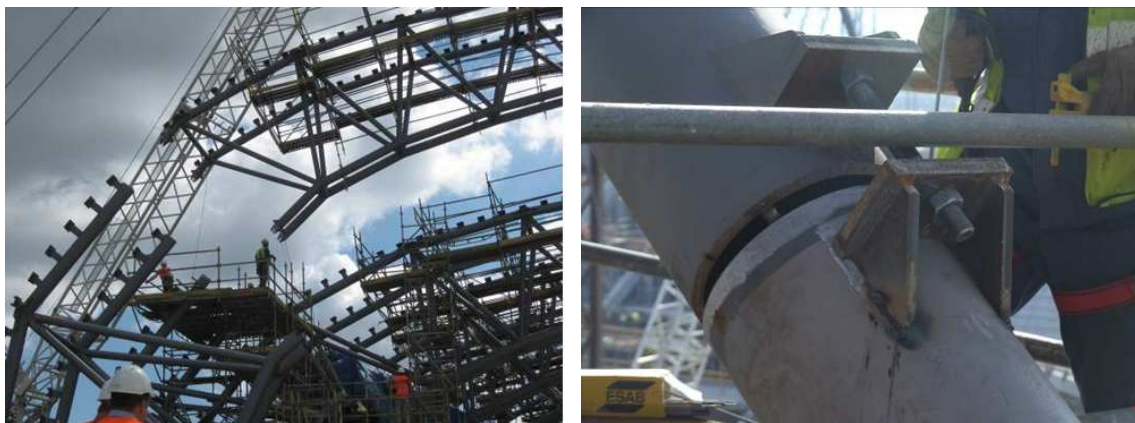
Fig.13 Connecting the roof part of the girder with the facade part

The next problem appeared while fitting the connecting roof part of the girder to the façade part. It was hard for the contractor to connect the two parts precisely in the four points keeping the whole girder in the correct position. In the few first girders, a gap between the two parts of one tube was too big (fig. 13). Tightening was very easy by regulation of the free end of the girder but in this case it was absolutely forbidden, due to the additional internal stress in the range of 200 MPa. In that case the contractor had to cut off about 700 mm of the tube and insert a new fitted piece. After that the positioning procedures were upgraded and the problem was solved.

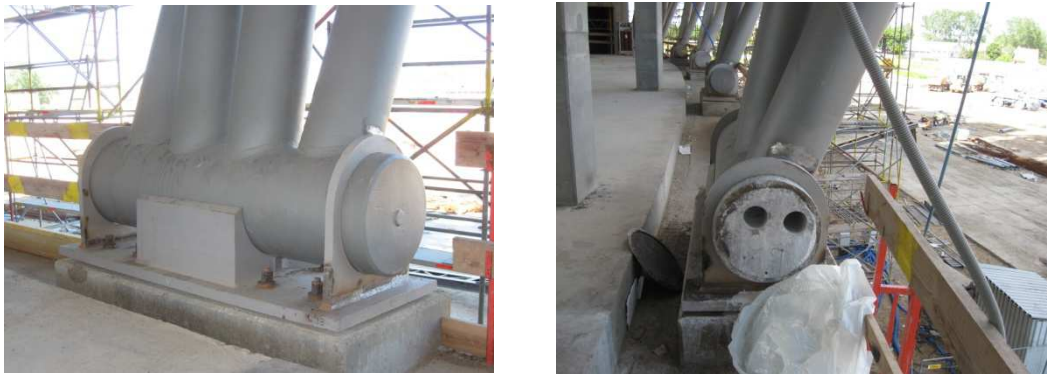
Fig.14 Support of the girder and the place where the samples were taken

An expected problem occurred with the support node filled with concrete (fig. 14). The support detail was designed as a hinge in the erection stages. The final shape was created by a steel designer to fulfil aesthetic aspects. The main element of the seating part designed as welded was finally manufactured as cast steel (decision of contractor). The horizontal tube was filled with concrete to increase its bearing capacity. The inspection of this concrete showed that its parameters do not correspond to the design assumptions (B-28 instead of B-50). The replacement of the concrete filling was hard due to the already erected structure and timetable. Therefore, we decided to analyze

1. shape distortion of the horizontal tube in the supporting node as a result of welding (detail shown on fig.14),
2. geometric deviations in gusset plates,
3. accuracy problems in the lengths of the tube members accrued while fitting the facade and the roof part of the girder,
4. problems with quality of filled concrete in the horizontal tube (supporting node).

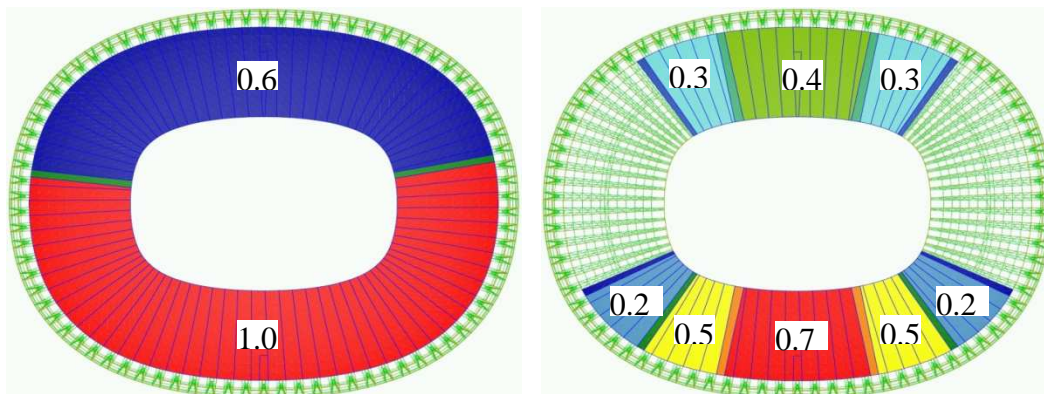
Fig. 19 Reference snow load in numerical

divided into small iteration steps, such an approach involves interaction between neighbouring girders. The effectiveness of the system was verified on several numerical tests (fig. 19, 20). In last step numeric model of the structure is used to predict stress level in every structural member under developed snow load.
